DOT/FAA/CT-94/79

Evaluation of Scanners for C-Scan Imaging for Nondestructive Inspection of Aircraft

Final Report

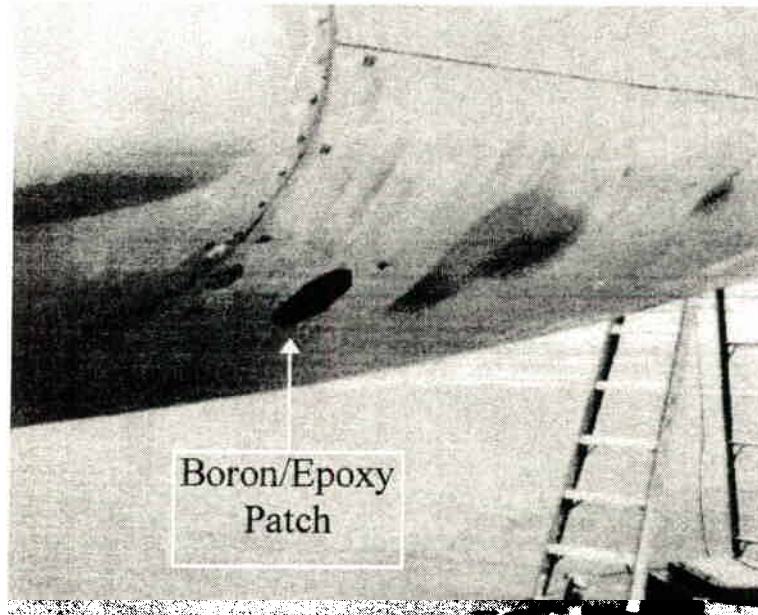
Octagonal shaped boron epoxy patch applied to the skin of the B737 airplane aft of the wing on the left side of the airplane.

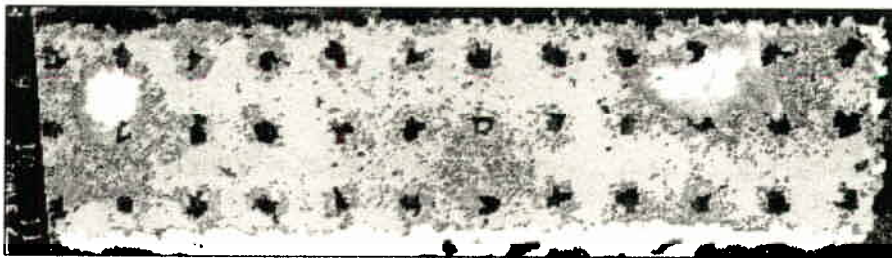
Intergranular Corrosion Sample, 0.040 inch thickness with ~ 0.007 inch depth corrosion

Krautkramer, Branson, Hocking manual scanner. Corrosion is shown in orange and white

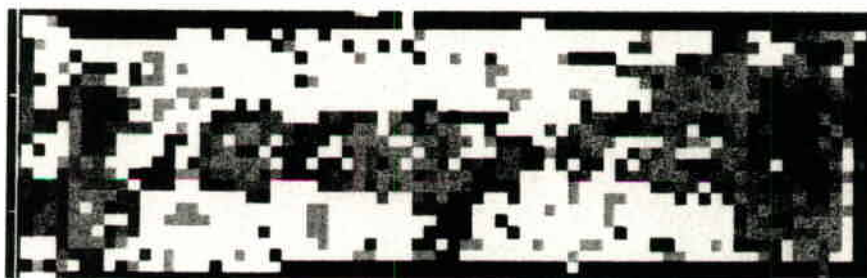
SmartEDDY manual scanner. Corrosion is shown in green and dark blue.

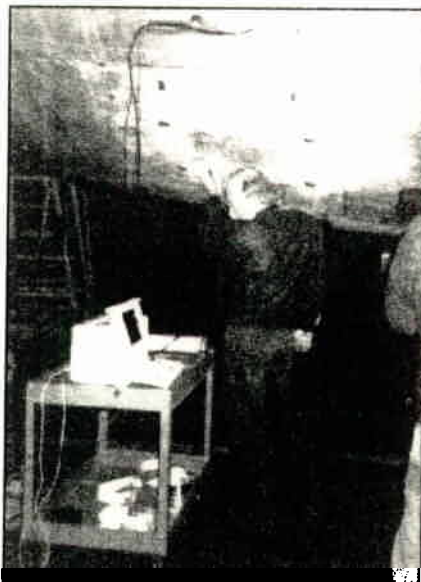
SmartEDDY Systems acoustic triangulation manual scanner shown at left is being articulated by Duane Johnson to obtain the above C-scan image at BS 877 and 887. Corrosion is shown in dark green and yellow.

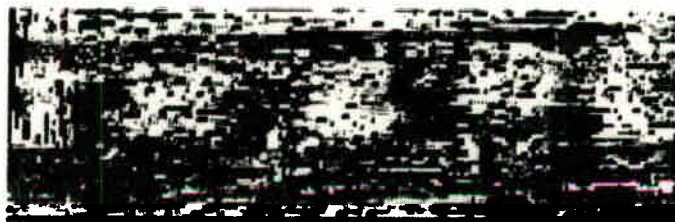
Infometrics manual scanner image of the defects in the six ply region of the sample. The defects are in yellow.

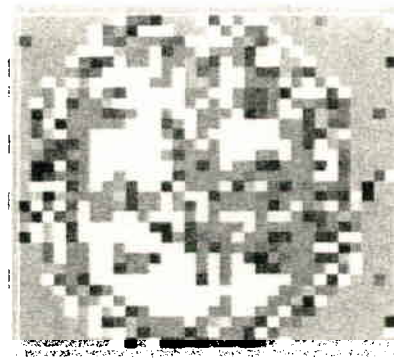
Image of repair patch showing defects in dark blue and green.

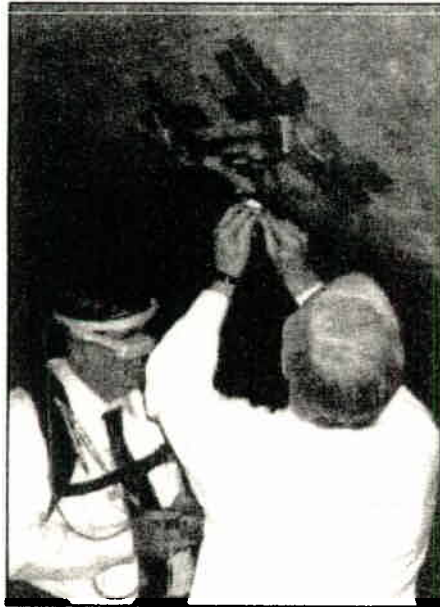
Sierra Matrix and heads up display with a manual scanner attached to the B737. Meaningful C-scan images of the corrosion at BS 877 were not obtained.
